670 W. Laurel Street, Colton, CA 92324  
<https://www.colton.k12.ca.us/cms>

COLTON MIDDLE SCHOOL  
**PROPOSED SITE MASTER PLAN**

Colton Joint Unified School District  
 Long Range Facilities Master Plan

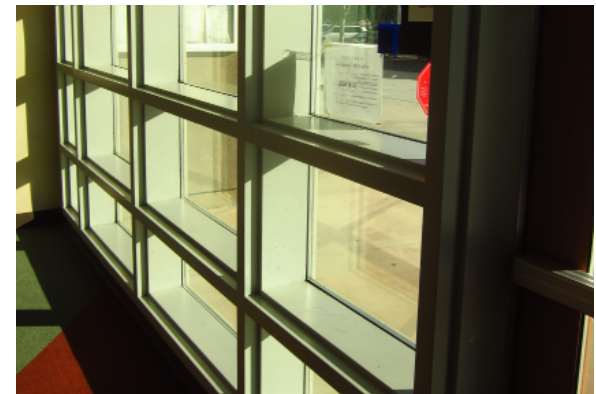
Typical exterior window condition.

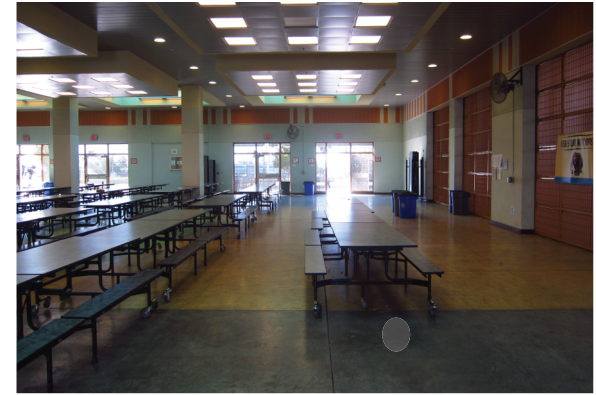
Indoor/outdoor lunch shelter, open to the elements.

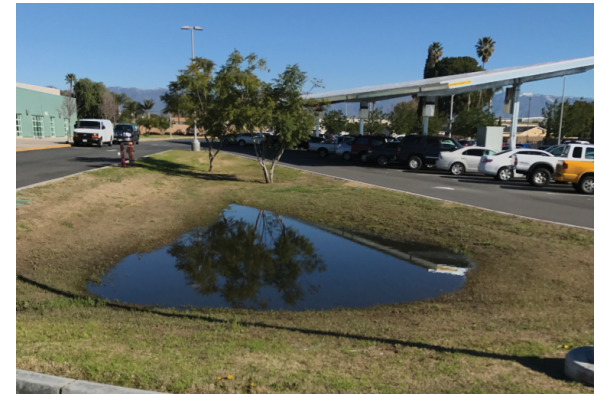
Ponding water from recent rains at front parking lot swale.

- Excessive ponding observed in parking lot retention areas. Drain inlets require repair.
- Miscellaneous tree planters require tree replacement.

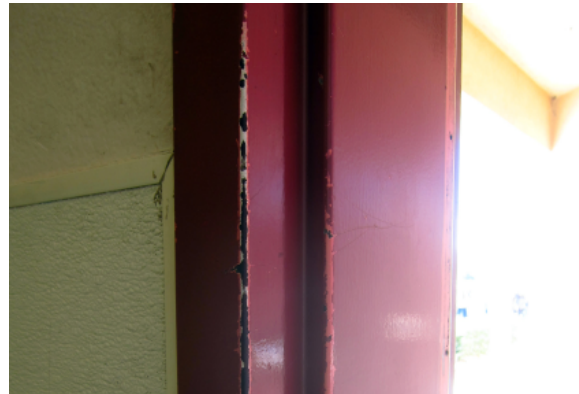
Paint deterioration at door frames with heavy traffic.

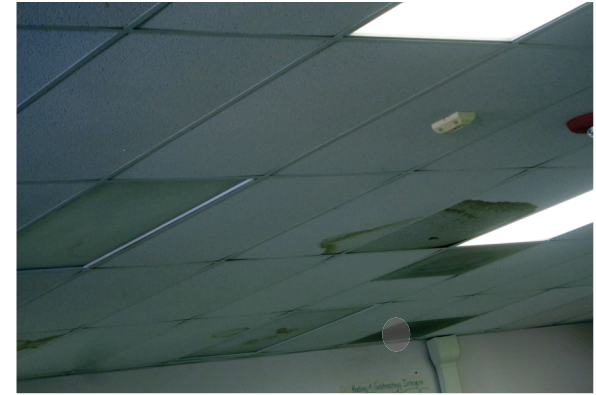
Significant water damage at ceiling tiles.

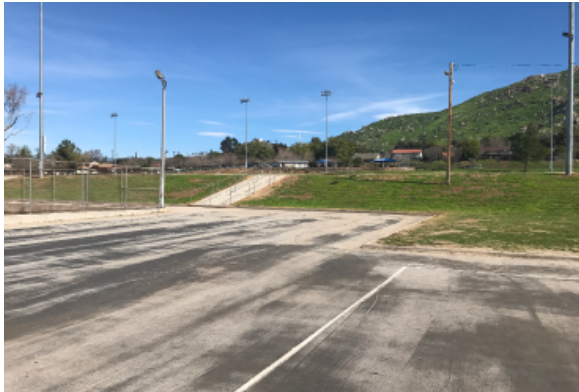
Deteriorated AC paving at hard courts.

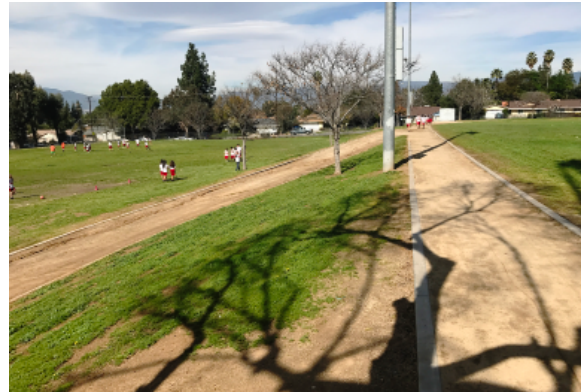
Update photo and caption.  
Field area with irregular slope.

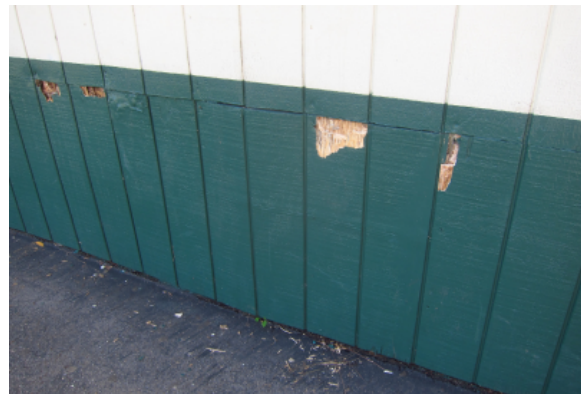
Example of damaged wood siding at modular building.

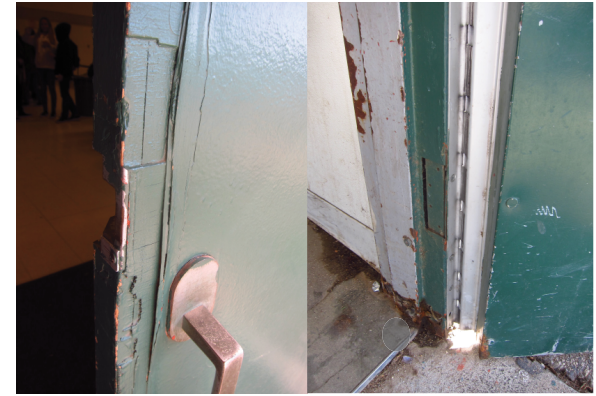
Examples of severely damaged door.

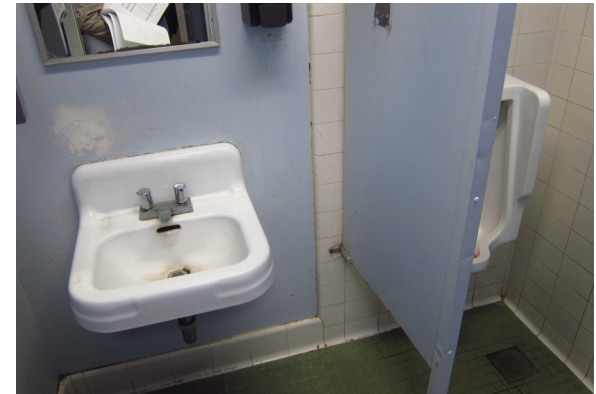
Non-accessible student restroom.

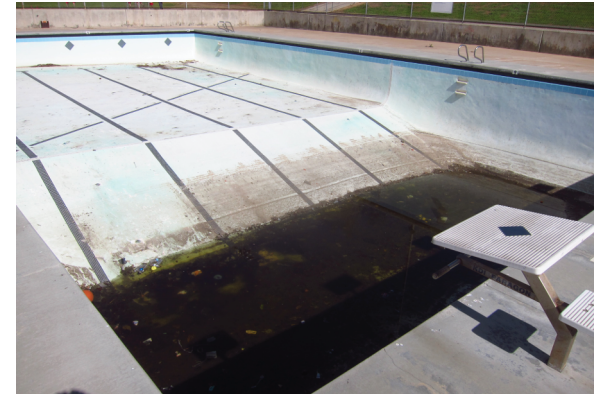
Abandoned swimming pool.

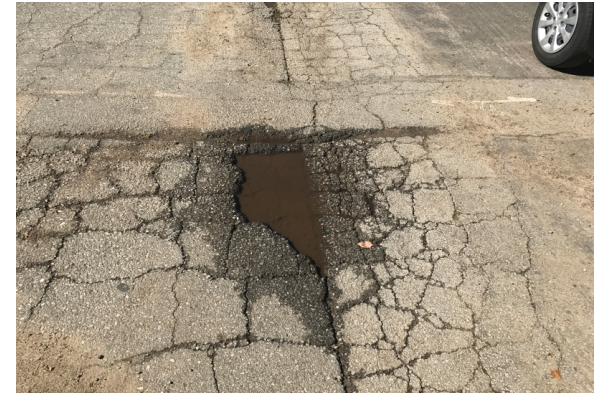
Significant damage to AC paving.

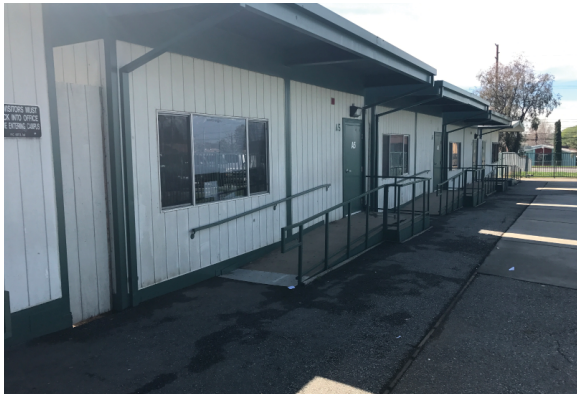
Evidence of ponding water at AC paving at portable buildings.

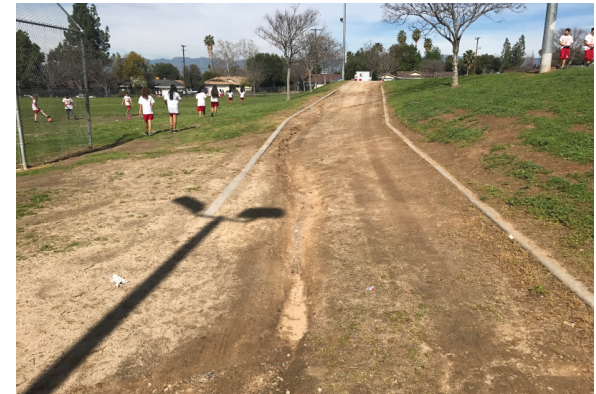
Track condition.
