670 W. Laurel Street, Colton, CA 92324  
<https://www.colton.k12.ca.us/cms>

COLTON MIDDLE SCHOOL  
**PROPOSED SITE MASTER PLAN**

Colton Joint Unified School District  
 Long Range Facilities Master Plan

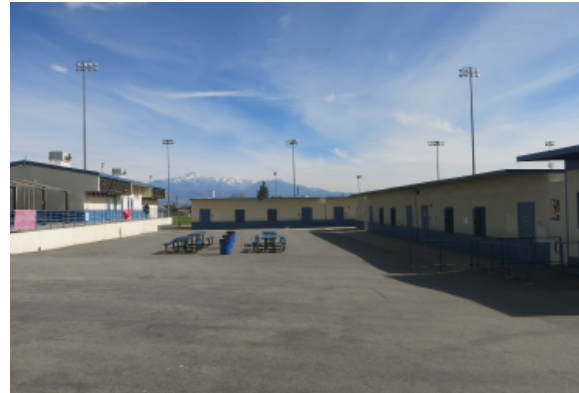
Hard courts/ Main Quad area; view towards portables.

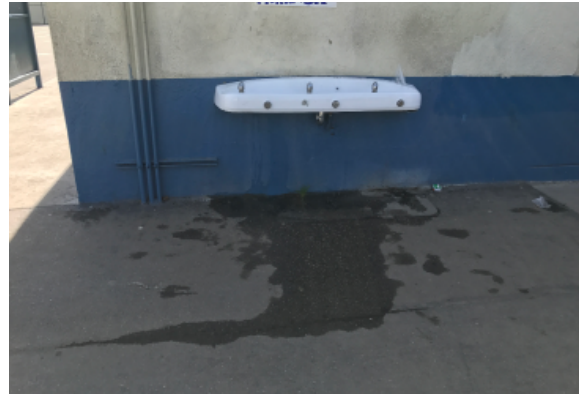
Typical drinking fountain.

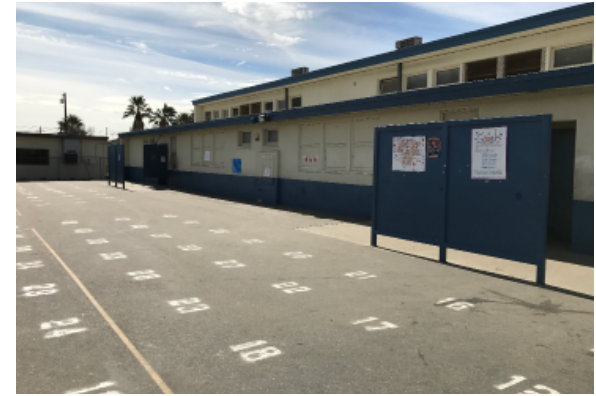
Locker room building.

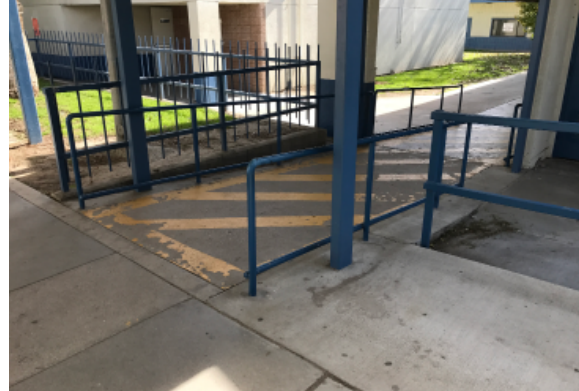
Ramp connecting main spine walkway to classroom wings.

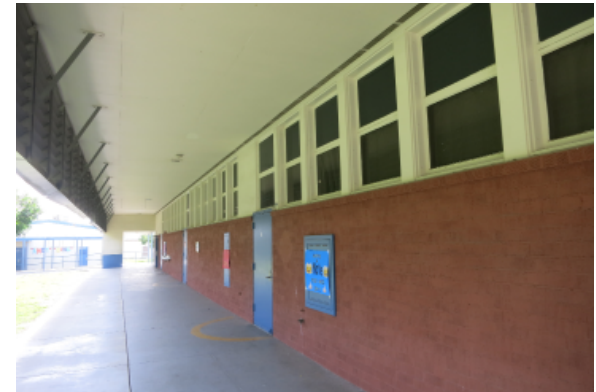
Typical classroom building.

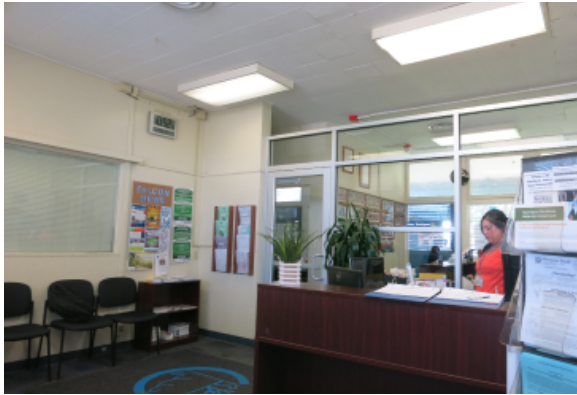
Main lobby at Administration office.

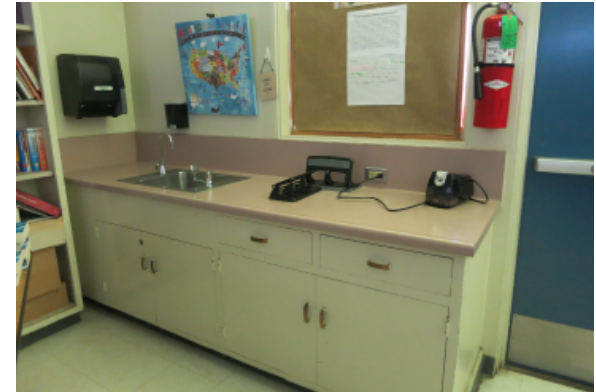
Typical classroom casework and sink.

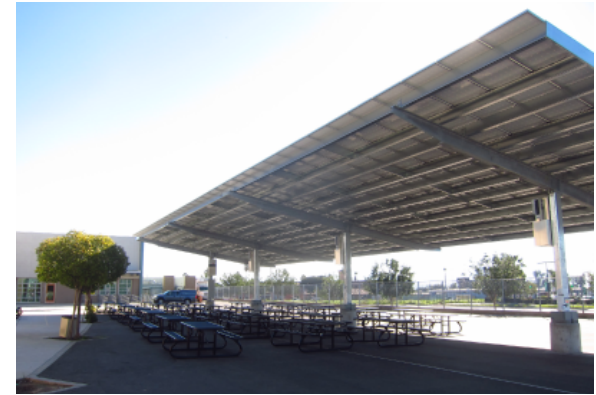
Newly installed solar photovoltaic shelter.

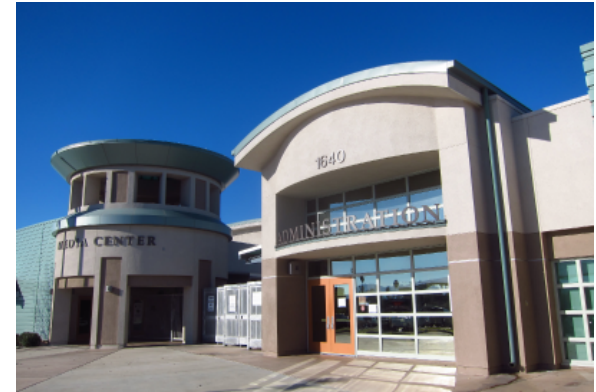
Front entry, Administration building, and media center.

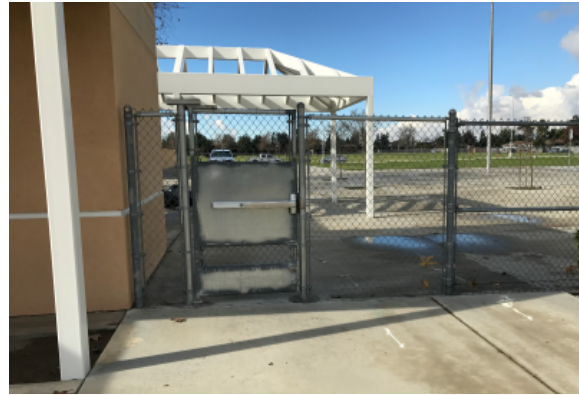
- Fencing finishes are old and in disrepair in some locations. New fencing is desired.
- Accessible hardware is missing on gate.
- Fencing fixtures, rails and mesh are damaged in areas.

Chainlink fencing and gate.

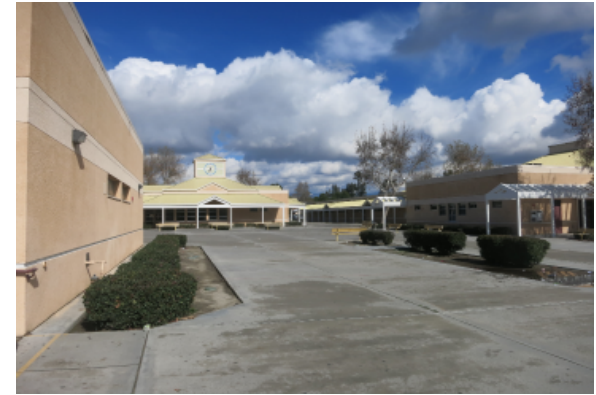
- Concrete paving in general is in fair condition with a lot of patchwork and grinding of lifted concrete.
- Portions of the sidewalk have minor lifting greater than 1/4"
- Cracking in panels
- Verify potential cross slope issues (>2%).
- Concrete joints are broken or sealant has eroded away.
- Recommend to replace 50% of concrete paving.

Exterior plaza and typical concrete.

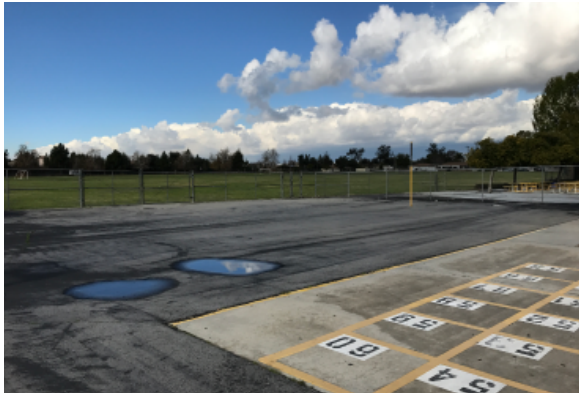
- Catch basins are plugged with debris/silt.
- Ponding occurs at low spots in paving, leading to water intrusion through cracked concrete.
- Recommend to have Trench Drains added to improve drainage system.

Hard courts with ponding water on asphalt and play fields.

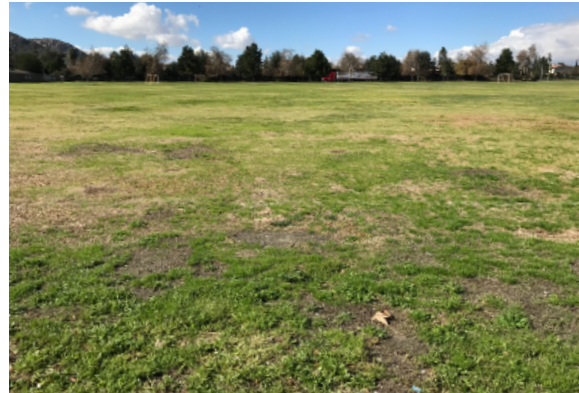
- Plant material is missing or nonexistent in several planter areas.
- Planter areas have no drainage inlets.
- Trees are in fair condition, however should be pruned and reviewed by an Arborist.
- Play fields are in poor condition and have gopher holes and uneven surfaces that present trip hazards.

Typical field condition.

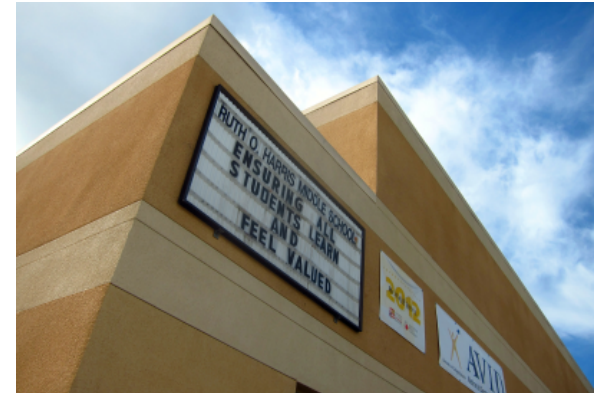
- Exterior of permanent buildings is mainly plaster. Plaster is in very good condition.

- Some fading observed on west-facing exposed walls.

Typical building exterior plaster condition.

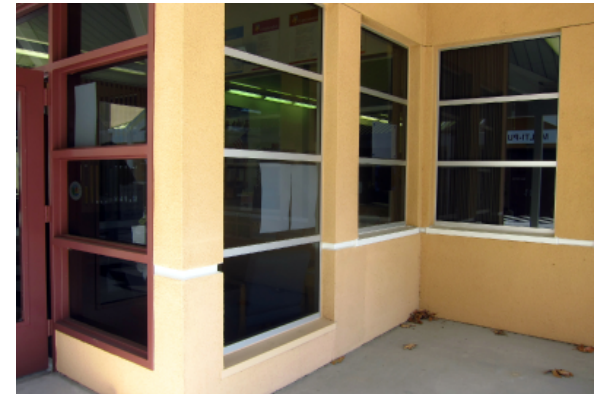
- Windows are single pane, with mix of hollow metal and aluminum frames in generally good condition.
- Glazing type leads to frequent overheating of classroom spaces during the warm months.

Typical exterior window condition.

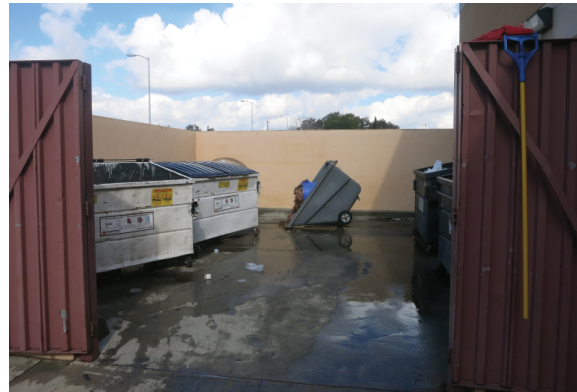
Outdoor trash enclosure with ponding water.

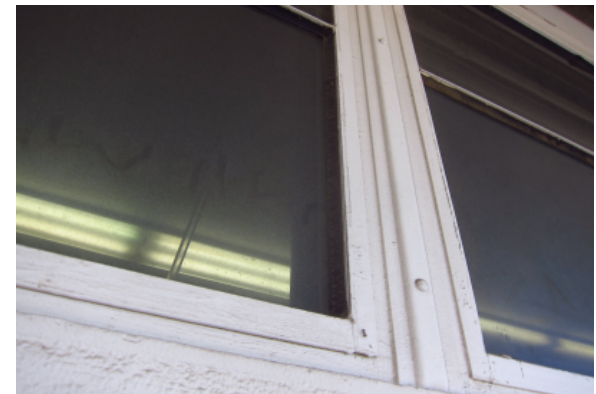
- Windows are single pane and aged.
- Window frames are mix of steel at permanent buildings and aluminum at modular buildings. Frames appear to be original to buildings and are in aged condition.

Typical exterior window condition.

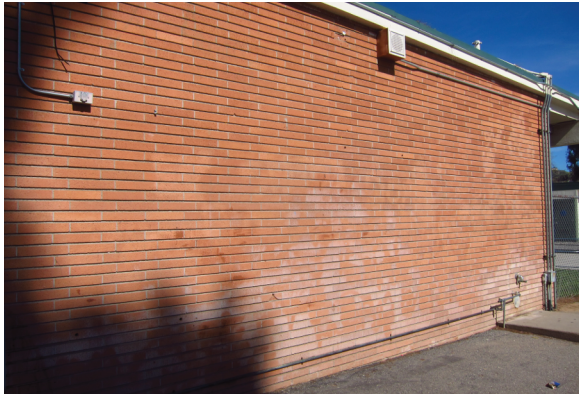
- Complaints of lack of curb appeal for school.
- Brick at existing permanent buildings is in fair condition. Some cracks and chipping observed. Plaster at existing permanent, modernized buildings is in good condition.
- The locker room building is in extremely poor condition. Noticeable deterioration of finishes observed.
- Modular buildings are deteriorated, with visible wood rot at many structures and broken fascia and wood siding pieces observed. Some of this may be due to exposure to play courts and damage from bouncing balls.
- Green accent paint was redone the previous year and is in excellent condition. White field paint is older and in fair condition.
- Paint at the locker room building is faded in great need of replacement.

Typical brick condition.

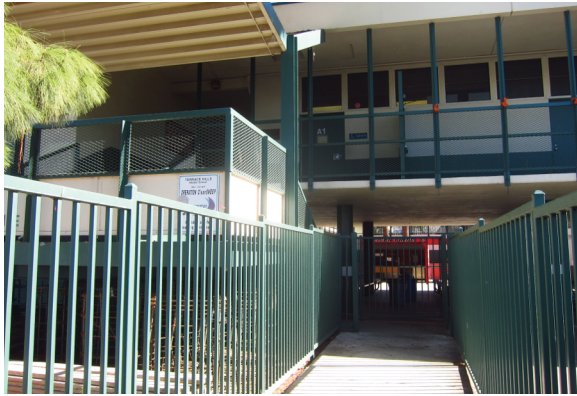
Current school entry, claustrophobic fencing and with stairs required up to Main Administration.

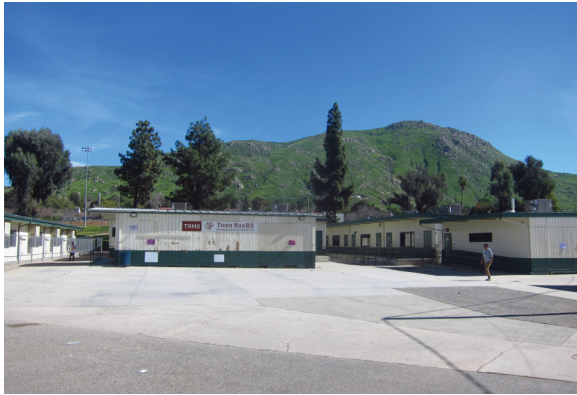
Significant quantities of modular classrooms across the site.

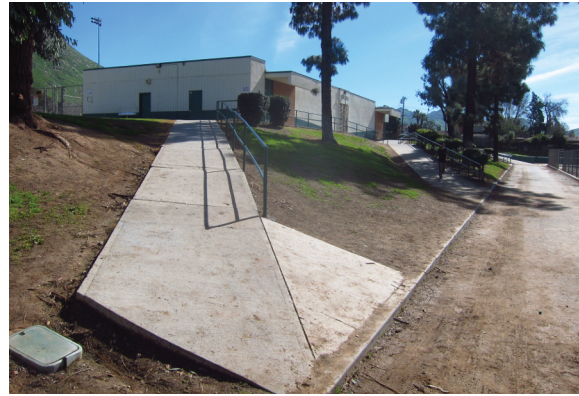
Inaccessible path of travel to locker room building.

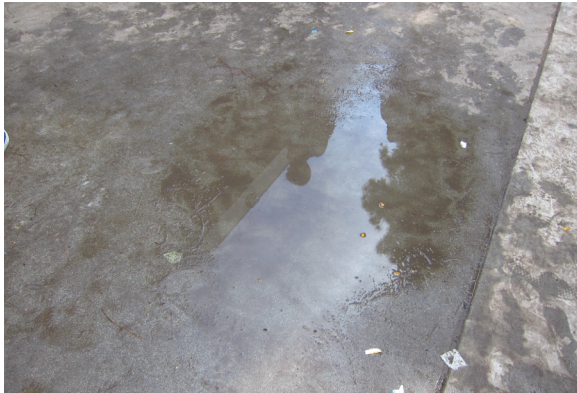
- Lunch area is not adequately graded resulting in ponding/standing water.
- Site has large grading variations and sloping. Slopes do not terminate into interceptor drains resulting in sediment/debris overtopping site curbs and being deposited on access roads.
- Ponding occurs outside staff lounge area. Drain inlets appear to have been designed to infiltrate water and are clogged with years of silt/sediment.
- Ponding occurring in parking lots due to pot hole conditions.

Ponding water at sunken outdoor dining court.
