670 W. Laurel Street, Colton, CA 92324  
<https://www.colton.k12.ca.us/cms>

COLTON MIDDLE SCHOOL  
**PROPOSED SITE MASTER PLAN**

Colton Joint Unified School District  
 Long Range Facilities Master Plan

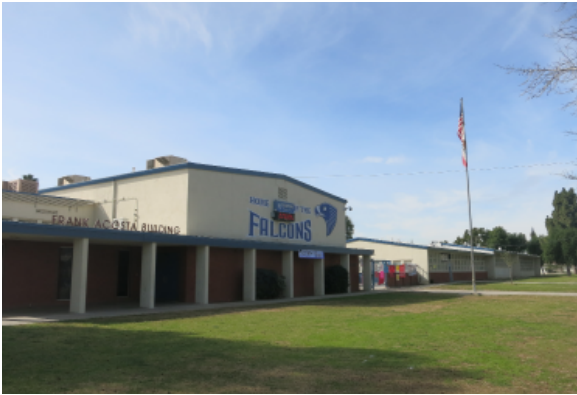
Front of school.

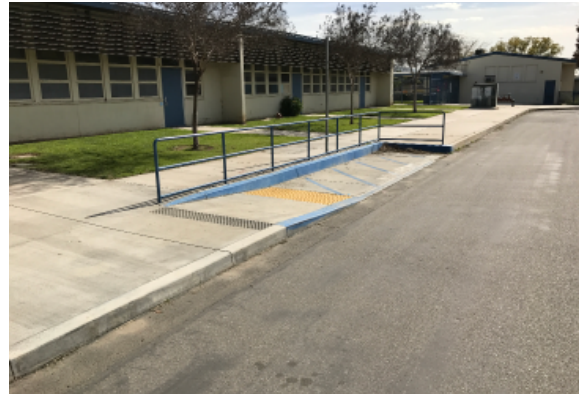
Drop-off at parking off of North Valencia Drive.

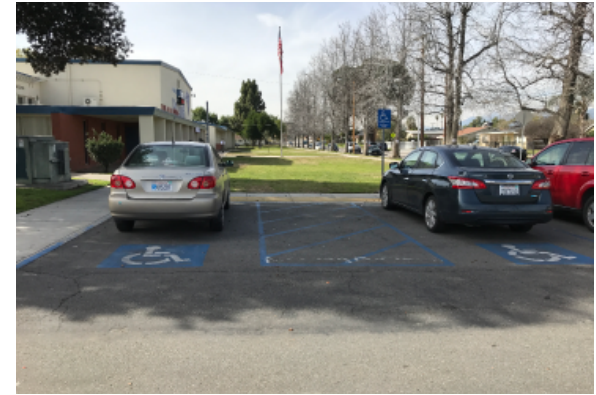
Parking off of West Laurel Street, and front of school, beyond.

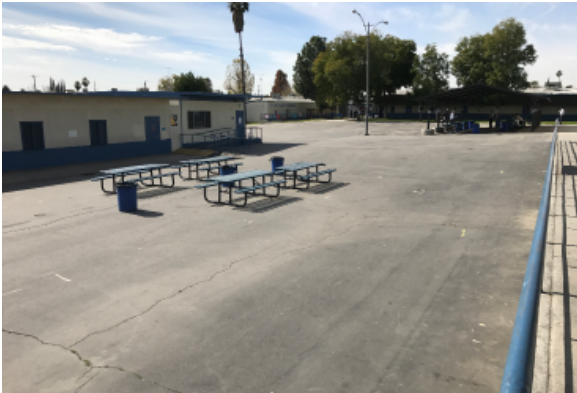
Hard courts/ Main Quad area.

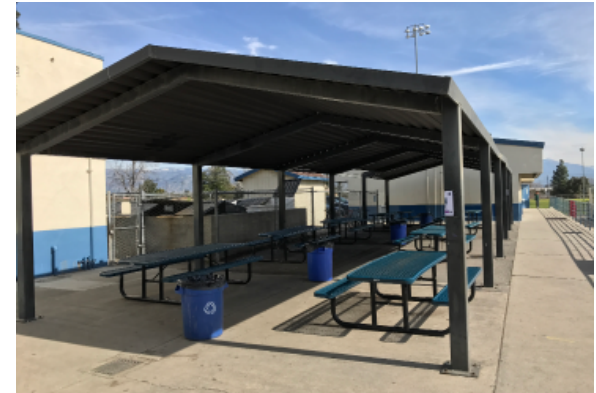
Lunch shelter East of MPR.

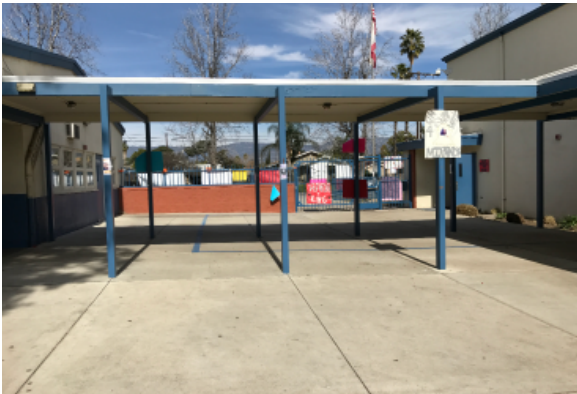
Main entry gate into campus, at front of school.

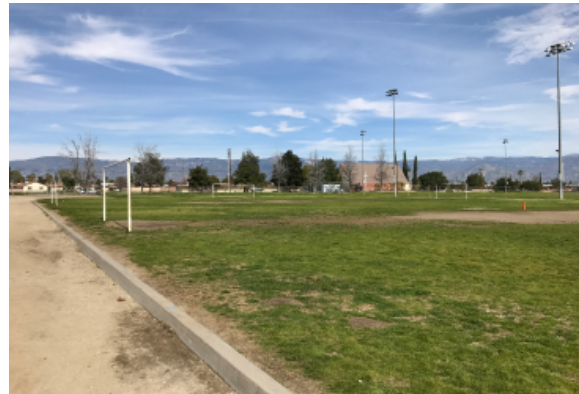
Dug track and play fields.

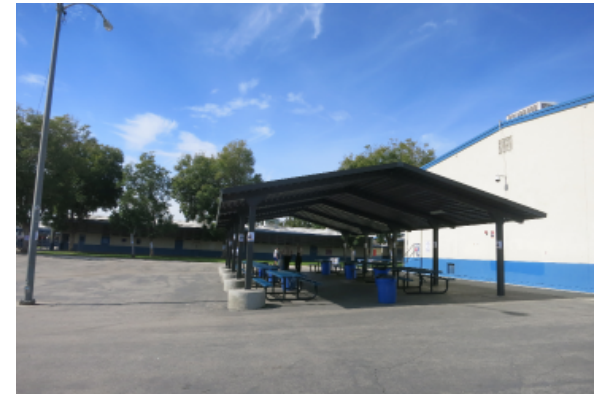
Lunch shelter at hard courts/ main quad.

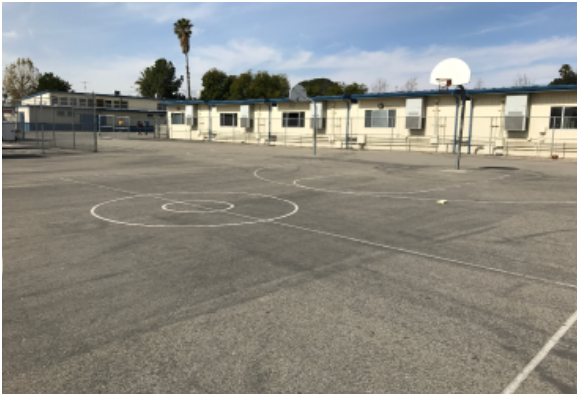
Hard courts South of the portables.

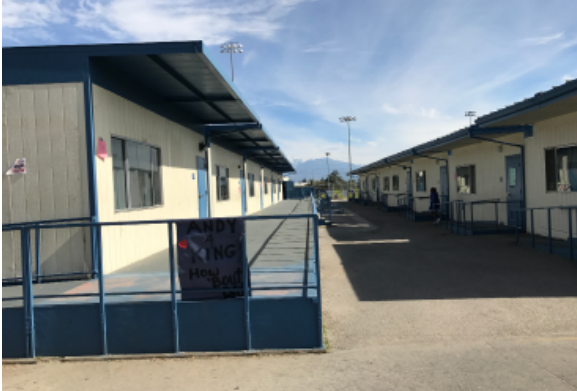
Portable classrooms.

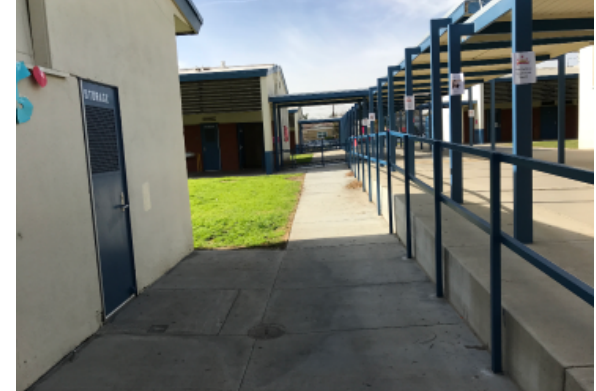
Main spine, walkway connecting classroom wings.

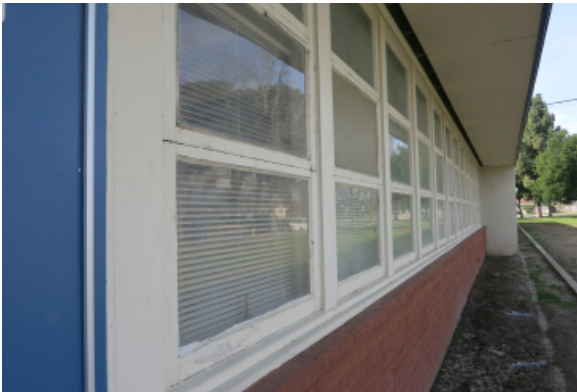
Typical windows.

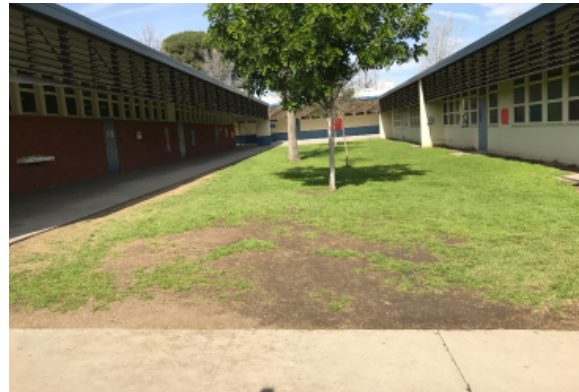
Typical outdoor space between classroom wings.

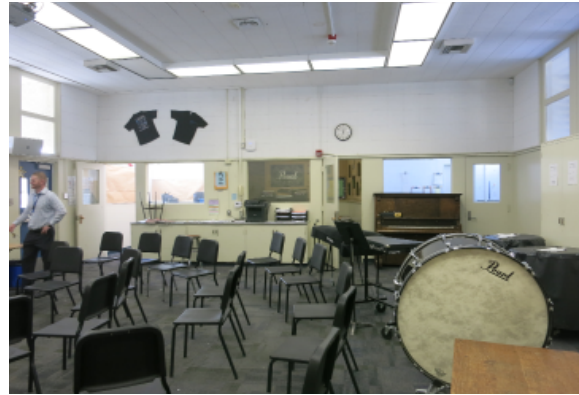
Band room.

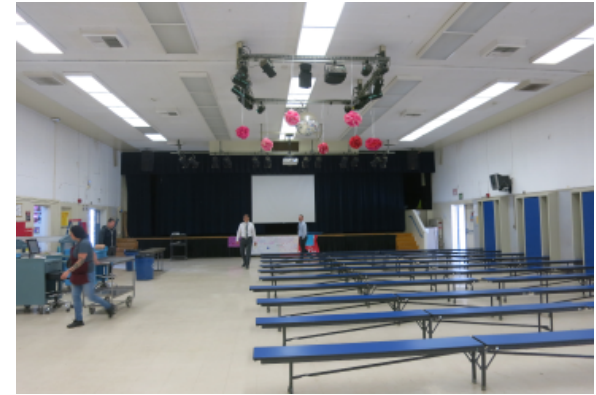
Multipurpose Room/ Cafeteria with stage.

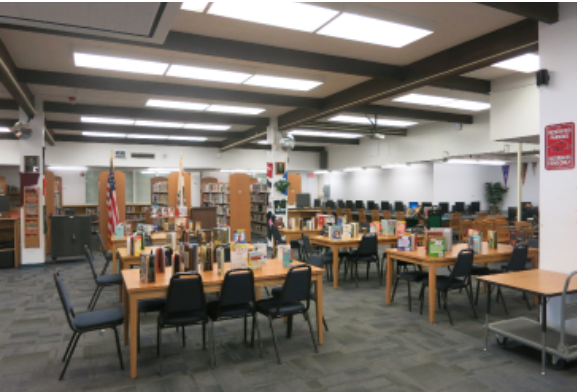
Library.

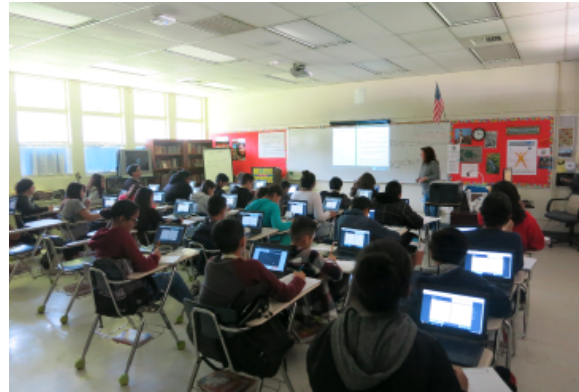
Typical classroom.

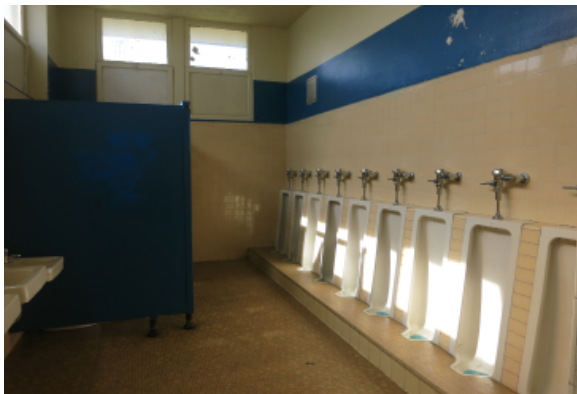
Typical restroom.

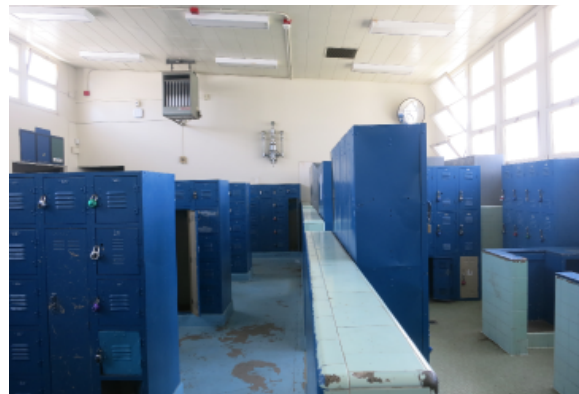
Locker room.

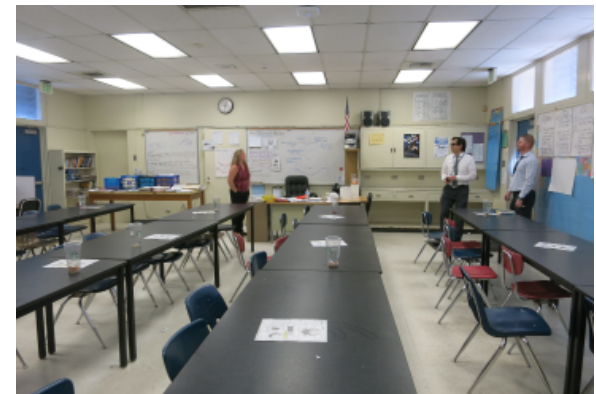
Art classroom.

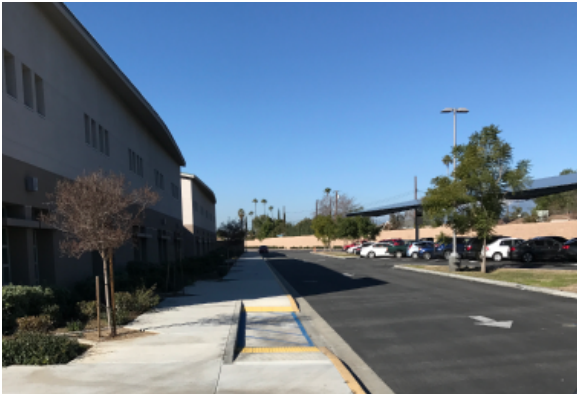
Accessible drop-off and side parking lot.

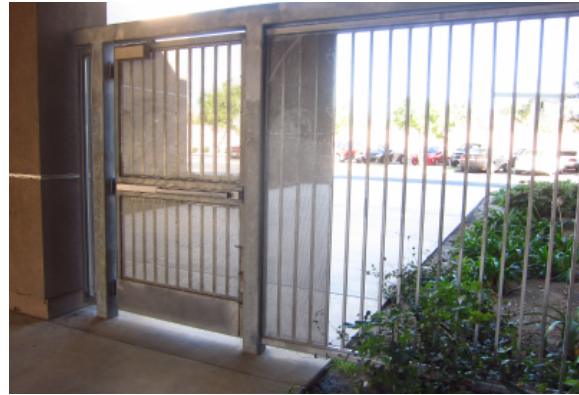
Tube steel fencing.

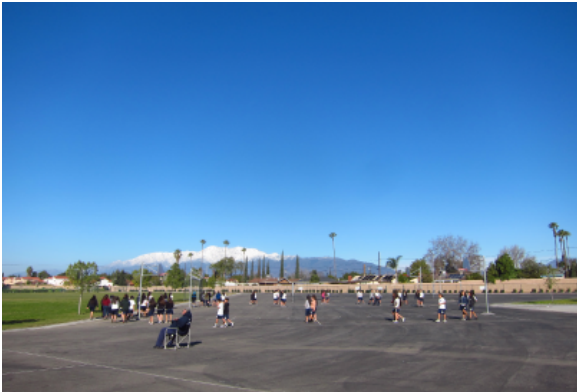
Hard courts and play fields.

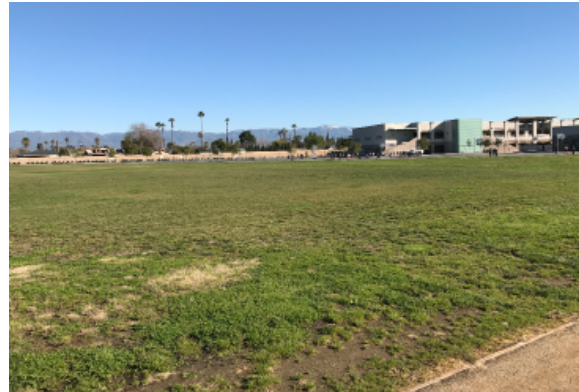
Field area.

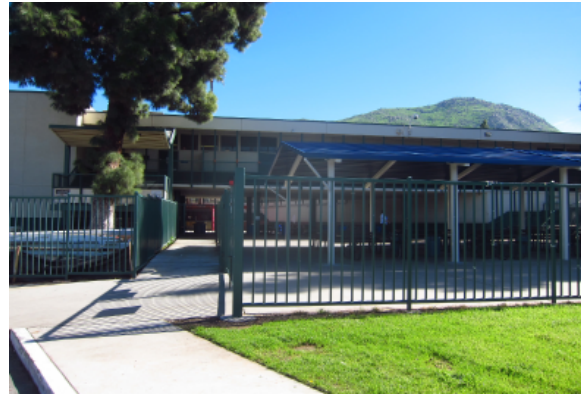
- Fencing around the site is a combination of wrought iron and chain link fencing. Fencing requires rust proofing and repainting in many locations.

Typical tube steel fencing.

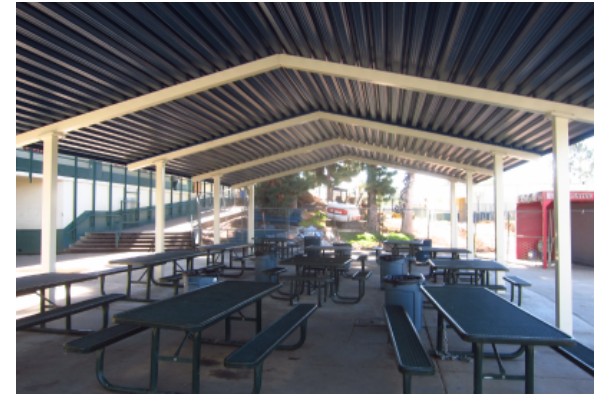
- Existing shade structures in lunch area is in good condition. PCC under shade requires patching/ replacement.

Lunch shade structure

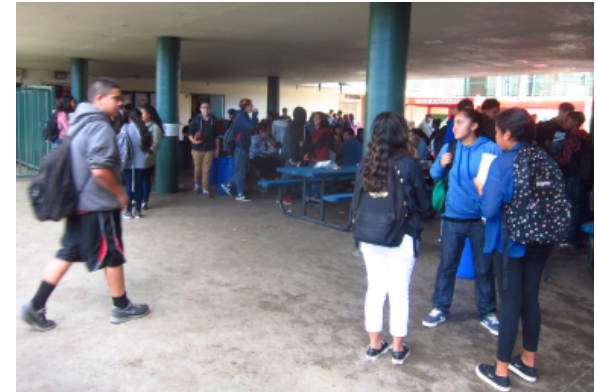
Outdoor student dining located underneath Main Administration Space.

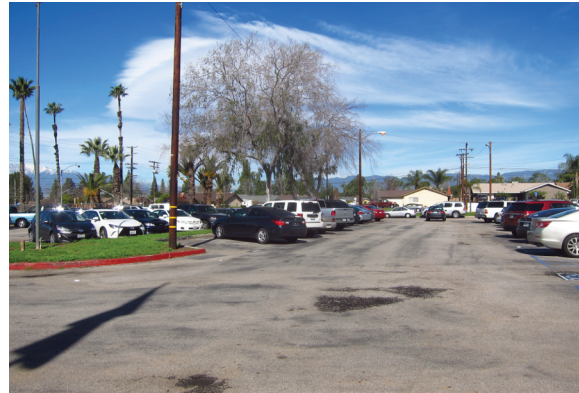
- School has noted that parking is insufficient for staff and visitor capacity needs. There is a proposed plan to expand parking westward toward Mount Vernon Avenue and relocate the vehicular entrance to this street.

Combination staff and visitor parking lot at capacity.
